Manhole Inspection Summary

Manhole # S45GG_049MH

Insp Date: **3/13/08 1:20 PM**

Location Address: **Ellsworth**

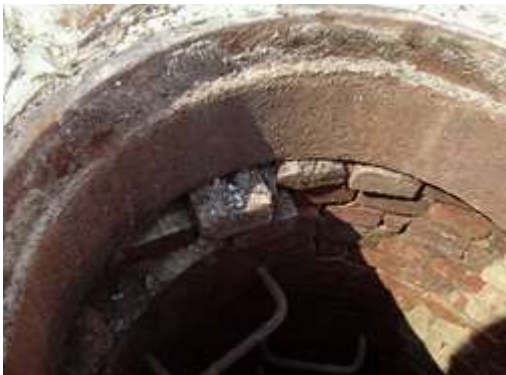
Defect 2

Frame Offset: **3** (in.) Condition: ☐ Sound ☐ Cracked ☒ **Leaks**

frame leaks

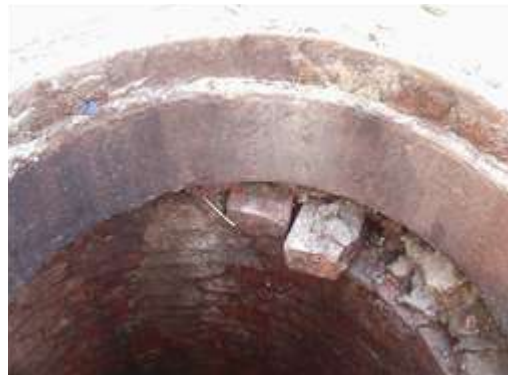
Defect 3

Condition: ☐ Sound ☐ Cracked ☐ Root Intrusion ☒ **Loose Brick** ☐ Deteriorated

loose bricks

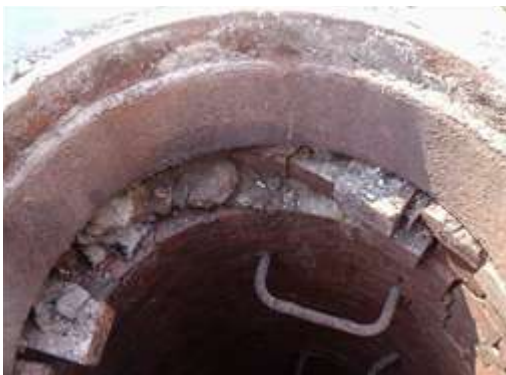
Defect 1

offset

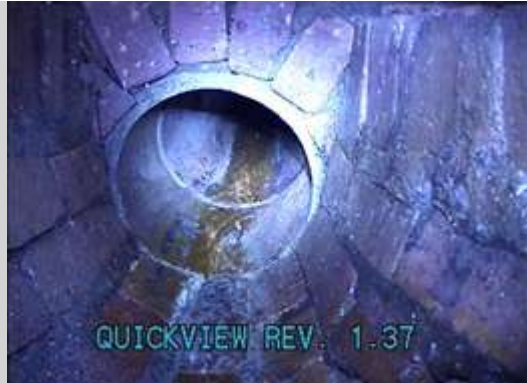
12 O'Clock Outflow

Pipe Height: **8.4** (in.) Rod and Bar (Angled)
Pipe Material: **Clay** ☐ Pipe Lined
Invert Depth: **10.50** (ft.) Flow Characteristics: **Fast**
Deposits: ☒ None ☐ Mud ☐ Sludge ☐ Debris ☐ Grease
Silt Depth: (in.) Deposits Extent:
Infiltration: **None** Pipe Seal Cond: **Sound**

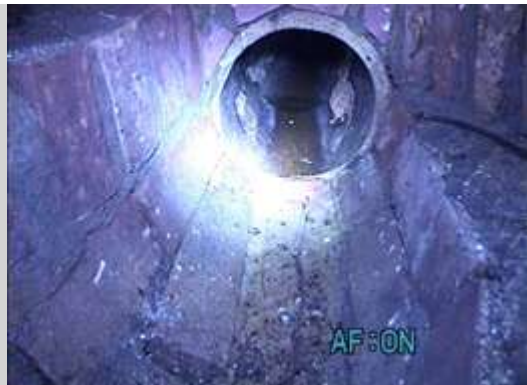
3 O'Clock Inflow

Pipe Height: **8.4** (in.) Rod and Bar (Angled)
Pipe Material: **Clay** ☐ Pipe Lined
Invert Depth: **10.00** (ft.) Flow Characteristics: **None**
Deposits: ☒ None ☐ Mud ☐ Sludge ☐ Debris ☐ Grease
Silt Depth: (in.) Deposits Extent:
Infiltration: **None** Pipe Seal Cond: **Sound**

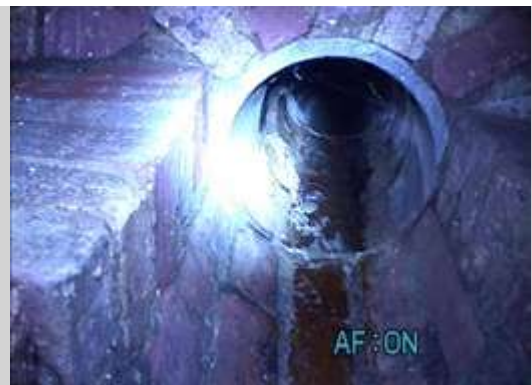
9 O'Clock Inflow

Pipe Height: **8.4** (in.) Rod and Bar (Angled)

Infiltration: **None** Pipe Seal Cond: **Sound**
